Observations of New and Reprocessed Octopus 3[®] Tissue Stabilizers and Octopus4[®] Tissue Stabilizers

The objective of this study was to evaluate new sterile and reprocessed sterile Medtronic Octopus 3[®] and Octopus 4[®] Tissue Stabilizers (see attached product PDF files). A report dated May 24, 2004 contained information and data describing the differences observed between new sterile and reprocessed sterile Medtronic Octopus 3[®] and Octopus 4[®] Tissue Stabilizers. In that report a total of four devices were assessed, one new sterile Medtronic Octopus 3[®], one new sterile Medtronic Octopus 4[®], one reprocessed sterile Medtronic Octopus 3[®] (SterilMed) and one reprocessed sterile Medtronic Octopus 4[®] (Alliance). Subsequent to that report, eight additional reprocessed Medtronic Octopus 3[®] and Octopus 4[®] Tissue Stabilizers from the same two reprocessors were examined using similar microscopic and molecular techniques. On June 7, 2004 the additional reprocessed Medtronic Octopus 3[®] and Octopus 4[®] Tissue Stabilizers were received. Results of eight of those are contained in this study for a total of twelve devices, two new sterile devices and ten reprocessed devices.

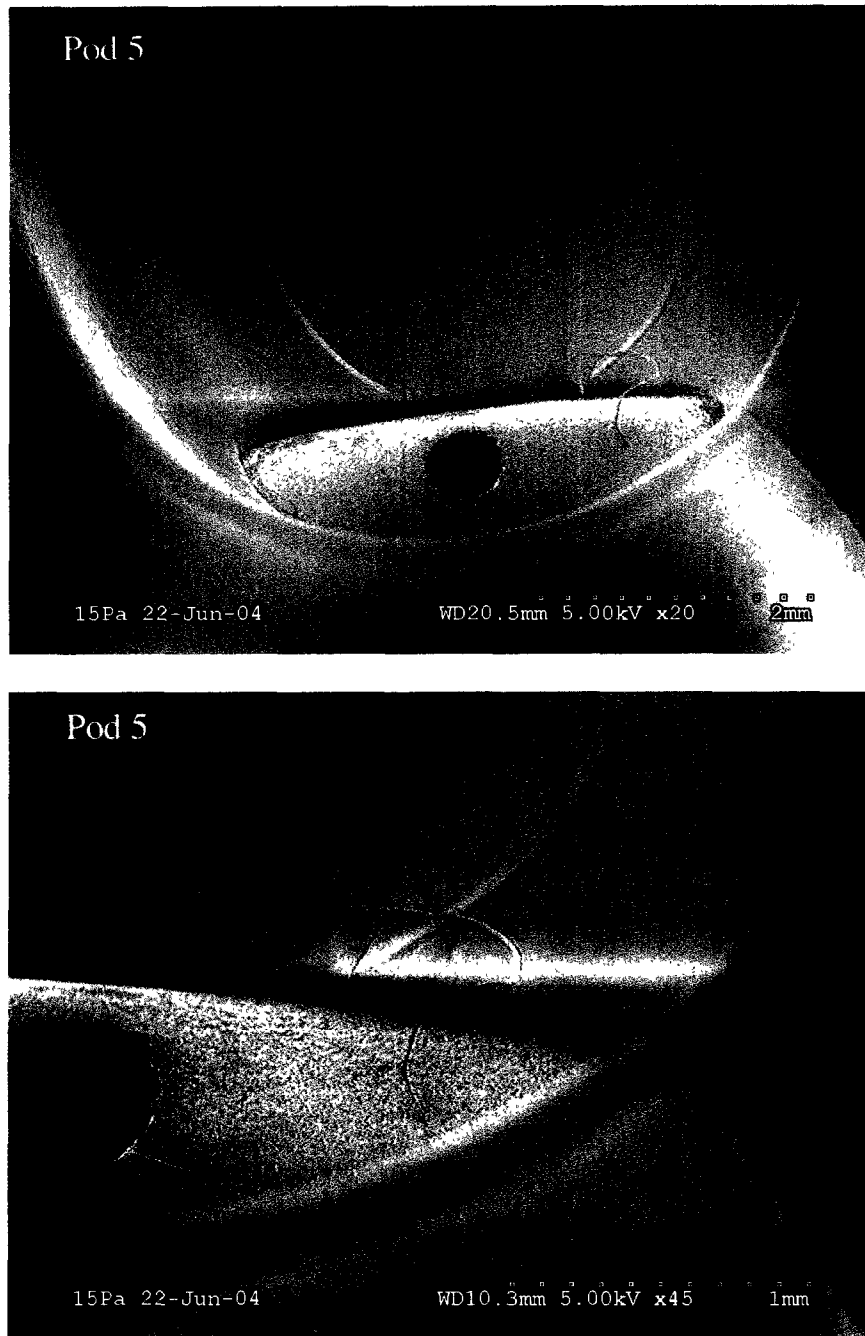
Figure 44. Series of images collected from Hitachi S3500N variable pressure scanning electron microscope in the areas of the tubing within the pods on the **reprocessed Octopus 3[®] MT-104-9**. The images show irregularities on surface structure of the tubing. Note the hair and the enlarged gap between the hypotubing and the pod. The numbers indicate the pod # (see Figure 5). Scale bar in each image.

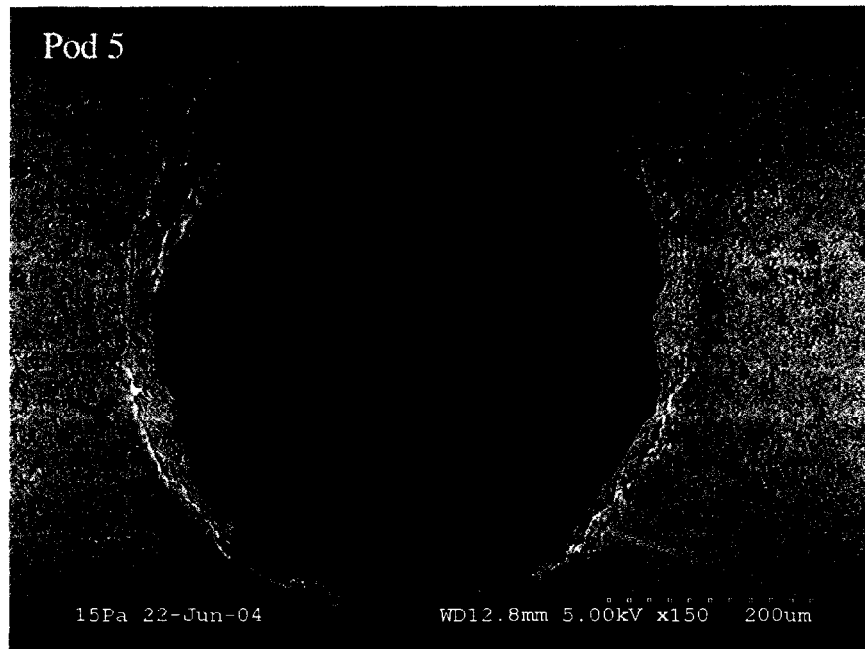
Figure 46. Image collected from Hitachi S3500N variable pressure scanning electron microscope in the areas of the hypotube opening of the **reprocessed Octopus 3[®] MT-104-9**. There is debris and irregularities present in the orifices of the tubing. The numbers indicate the pod # (see Figure 5). Scale bar in each image.

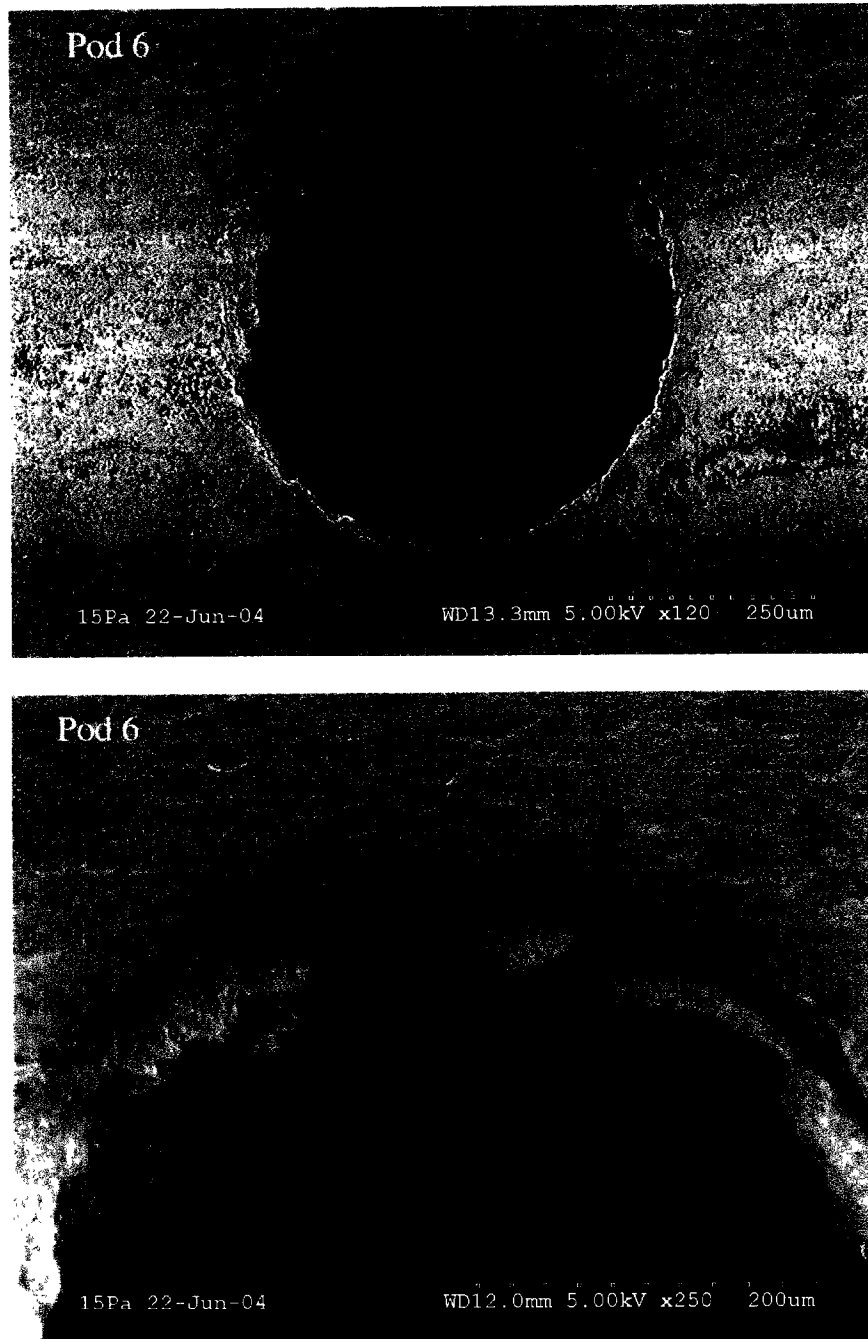
Figure 47. Image collected from Hitachi S3500N variable pressure scanning electron microscope in the areas of the hypotube opening of pod 6 of the **reprocessed Octopus 3[®] MT-104-9**. There is bioburden debris and irregularities present in the orifices of the tubing. The numbers indicate the pod # (see Figure 5). Scale bar in each image.

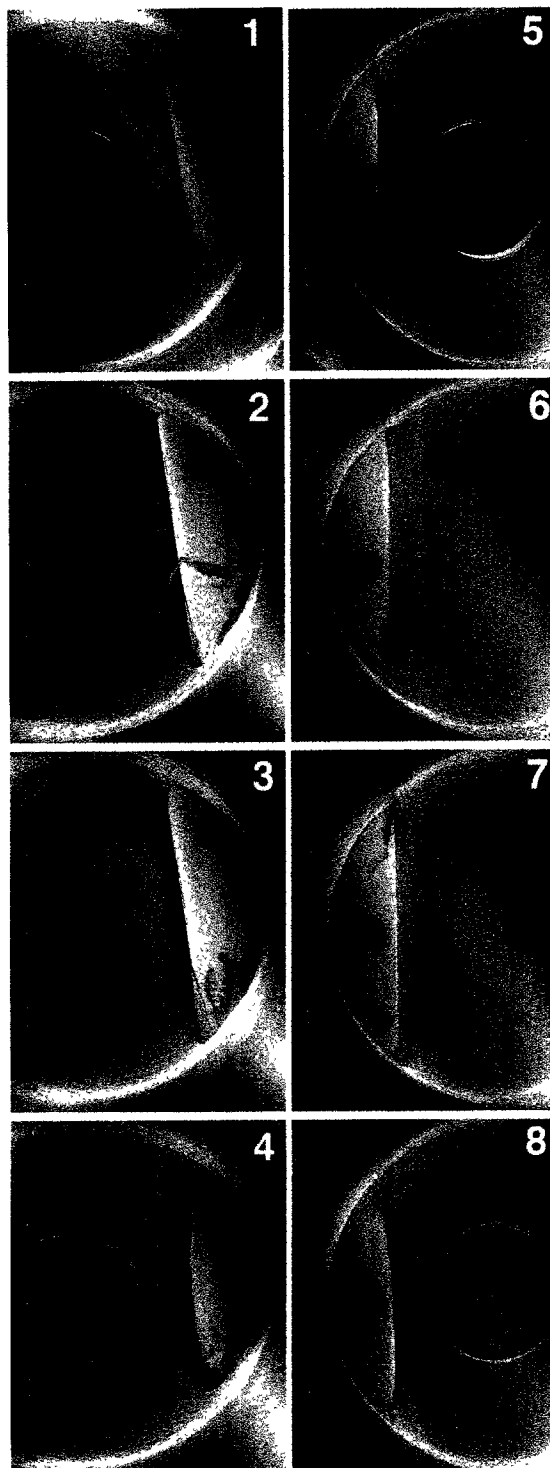
Figure 48. Series of images collected from Hitachi S3500N variable pressure scanning electron microscope of the pods on the **reprocessed Octopus 4[®] MT-104-10**. The images show various irregularities and contamination on the surface structure of the tubing and the pods. All images show foreign debris and contamination present on the surface of the tubing when compared to “new”. Scale bar in each image.

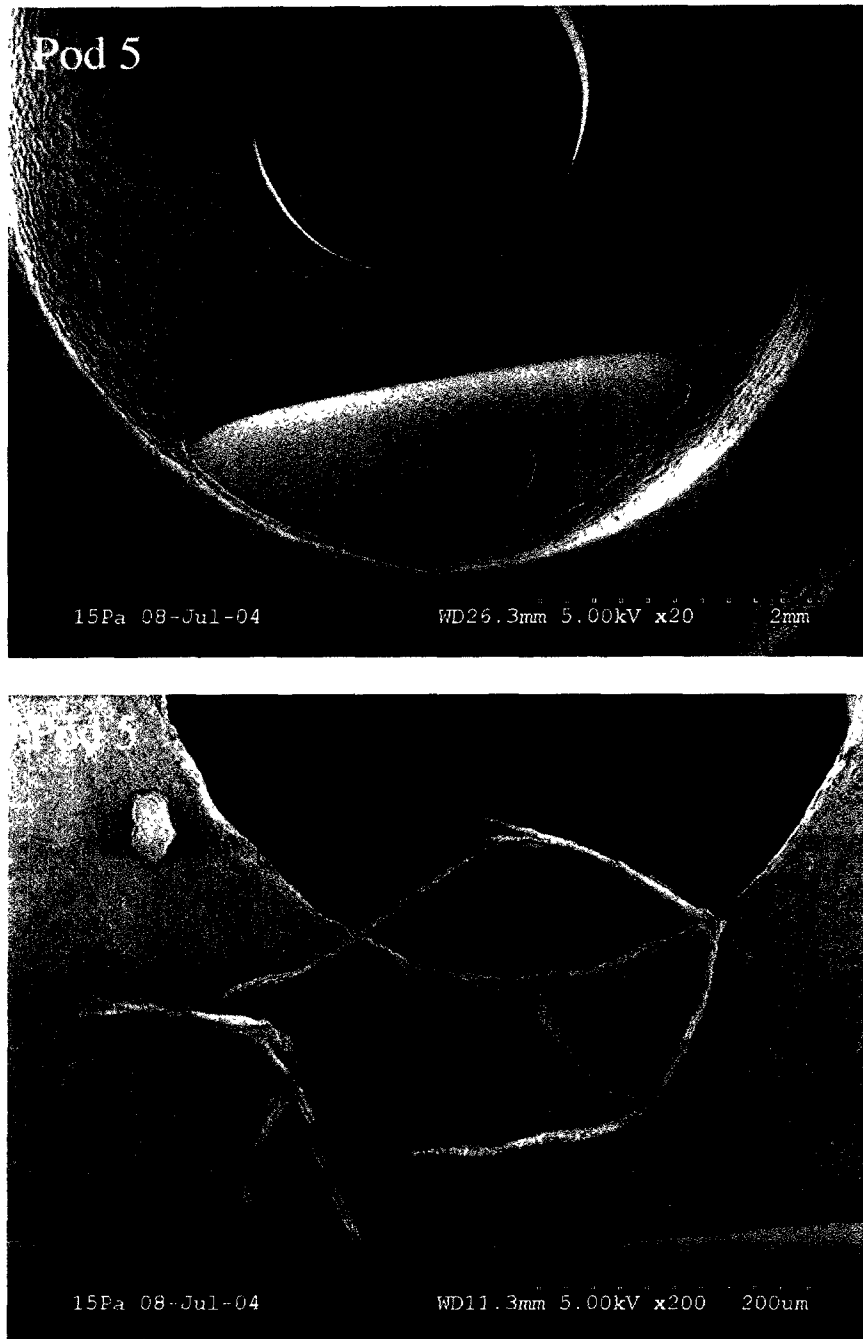
Figure 57. Images collected from Hitachi S3500N variable pressure scanning electron microscope in the areas of pod 5 on the **reprocessed Octopus 4[®] MT-104-11**. The images show hair-like fibers on surface of the hypotubing near the opening. There is also debris present in the surface of the tubing. The number in the upper left indicates the pod # (see Figure 5). Scale bar in each image.

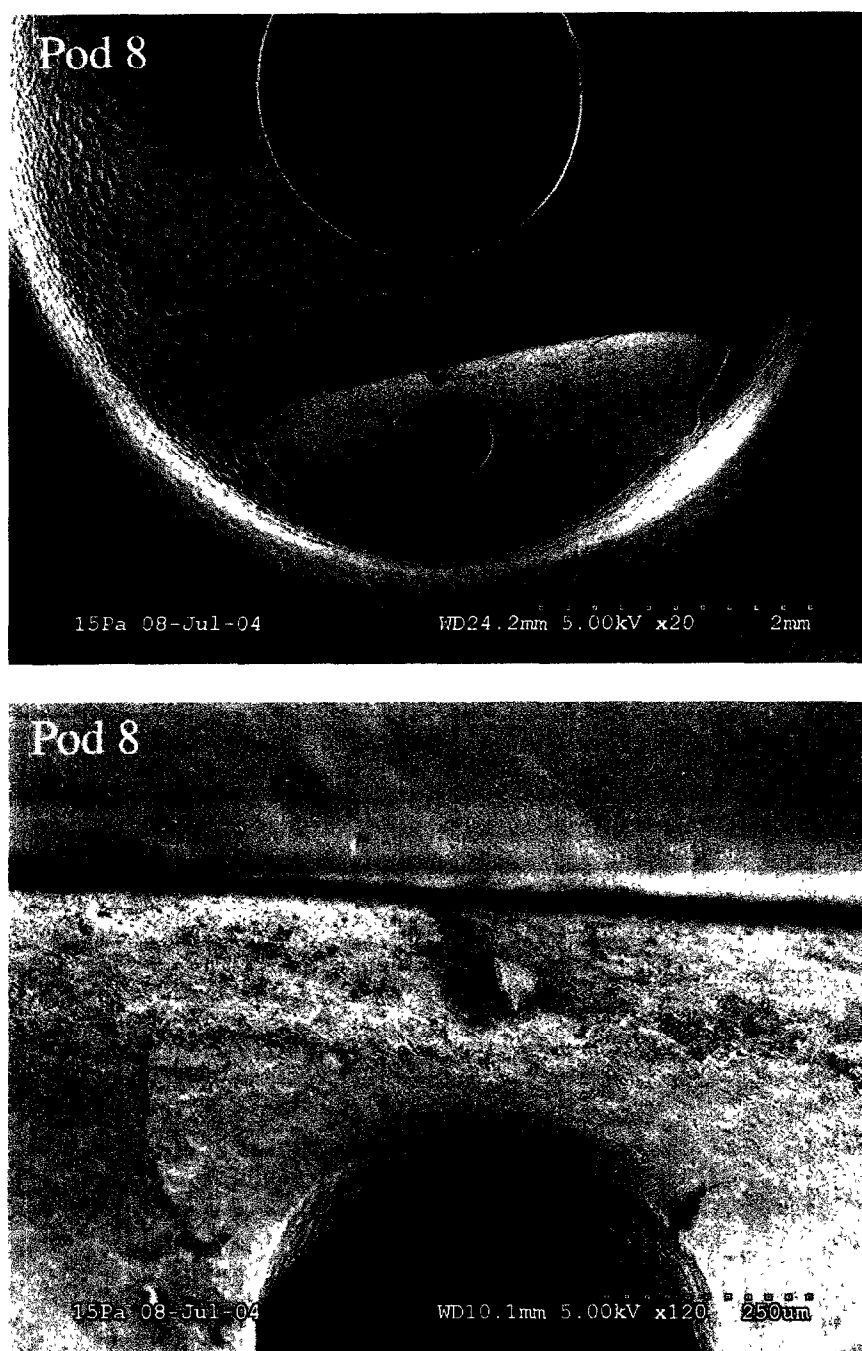
Figure 58. Images collected from Hitachi S3500N variable pressure scanning electron microscope in the areas of pod 8 on the **reprocessed Octopus 4[®] MT-104-11**. The images show contamination on surface of the hypotubing near the opening. There is also debris present on the surface of the tubing. The number in the upper left indicates the pod # (see Figure 5). Scale bar in each image.

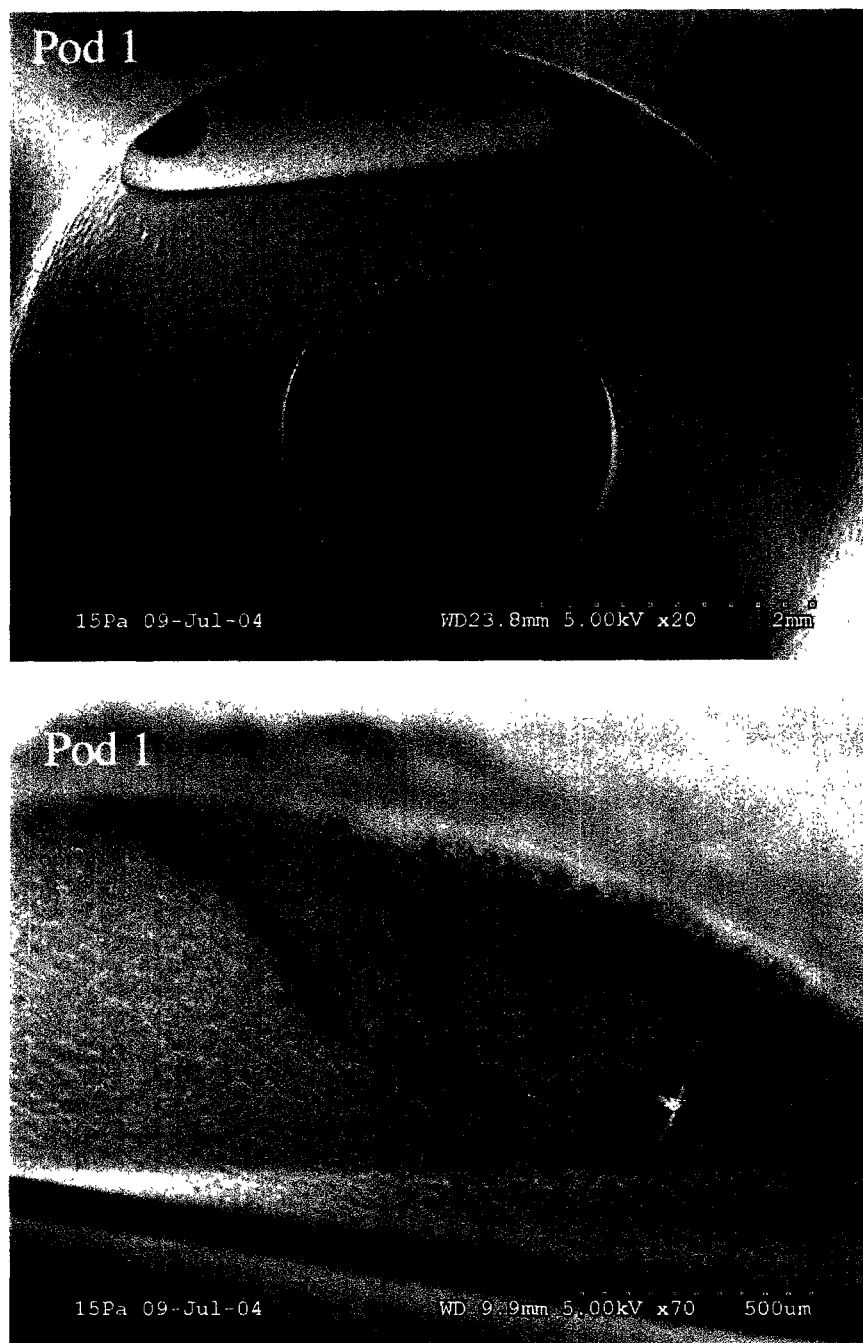
Figure 59. Images collected from Hitachi S3500N variable pressure scanning electron microscope in the areas of pod 1 on the **reprocessed Octopus 4[®] MT-104-13**. The images show contamination on surface of the hypotubing. The number in the upper left indicates the pod # (see Figure 5). Scale bar in each image.

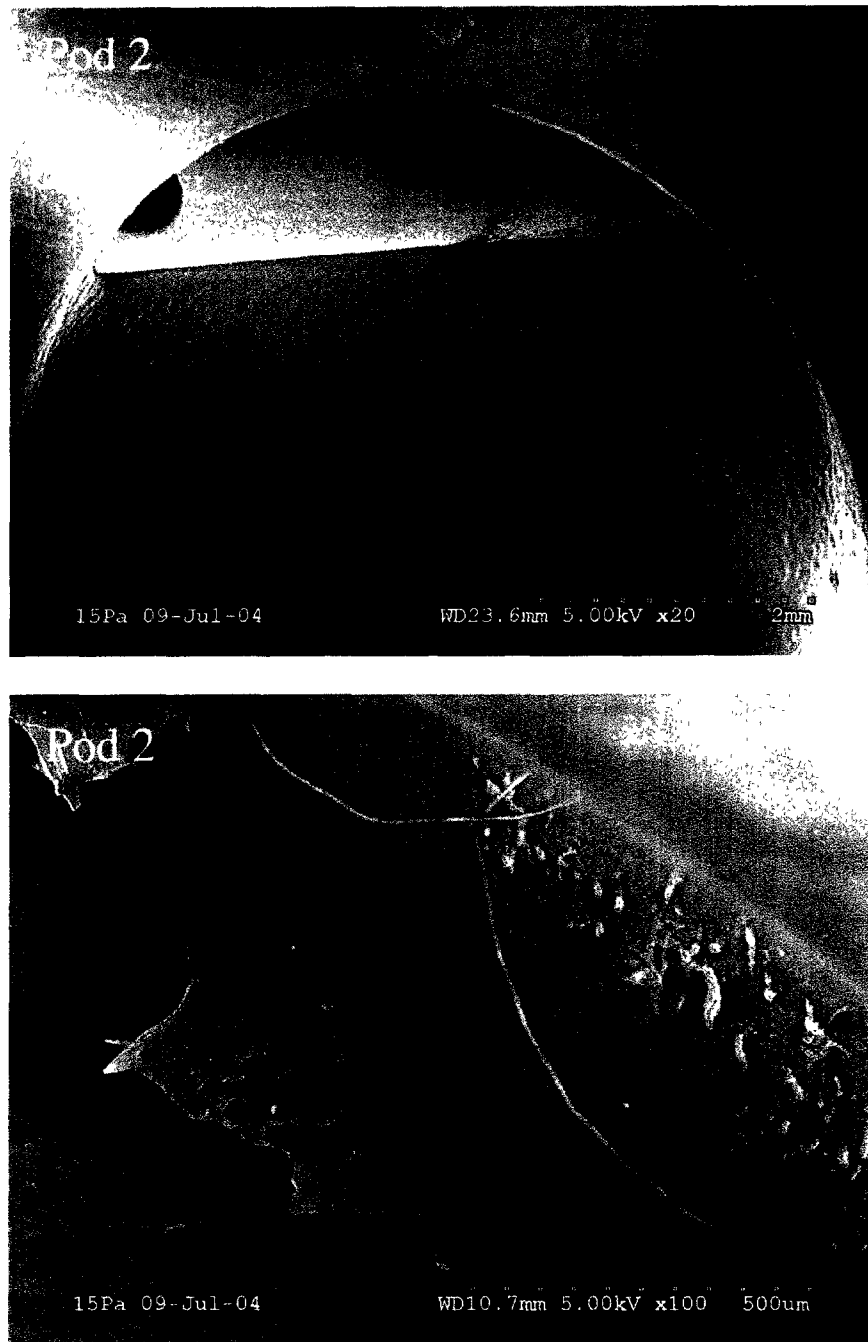
Figure 61. Images collected from Hitachi S3500N variable pressure scanning electron microscope in the areas of pod 2 on the **reprocessed Octopus 4[®] MT-104-13**. The images show contamination on surface of the hypotubing. Note sheet of bioburden and hair-like fiber. The number in the upper left indicates the pod # (see Figure 5). Scale bar in each image.

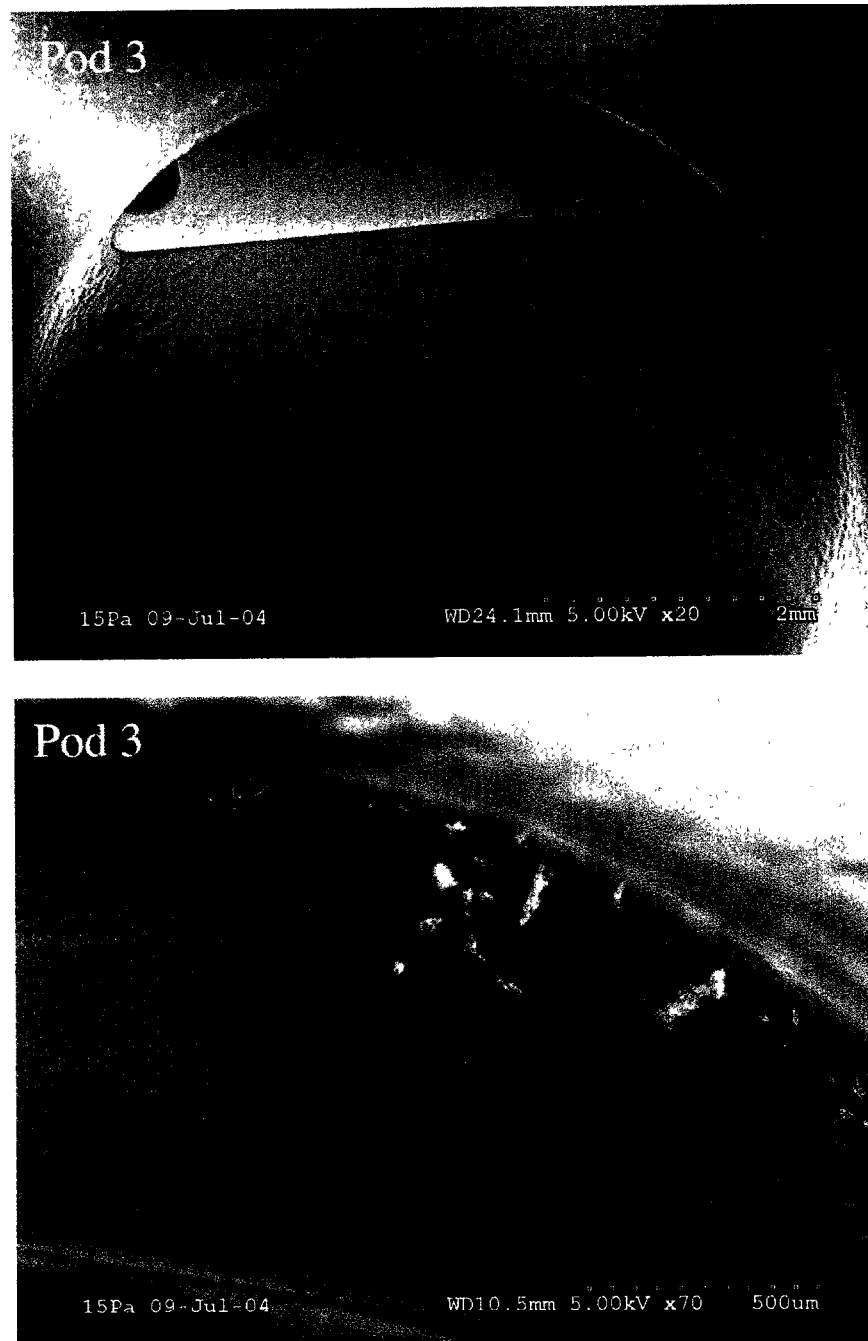
Figure 62. Images collected from Hitachi S3500N variable pressure scanning electron microscope in the areas of pod 3 on the **reprocessed Octopus 4[®] MT-104-13**. The images show contamination on surface of the hypotubing. Note sheet of bioburden on the hypotube. The number in the upper left indicates the pod # (see Figure 5). Scale bar in each image.

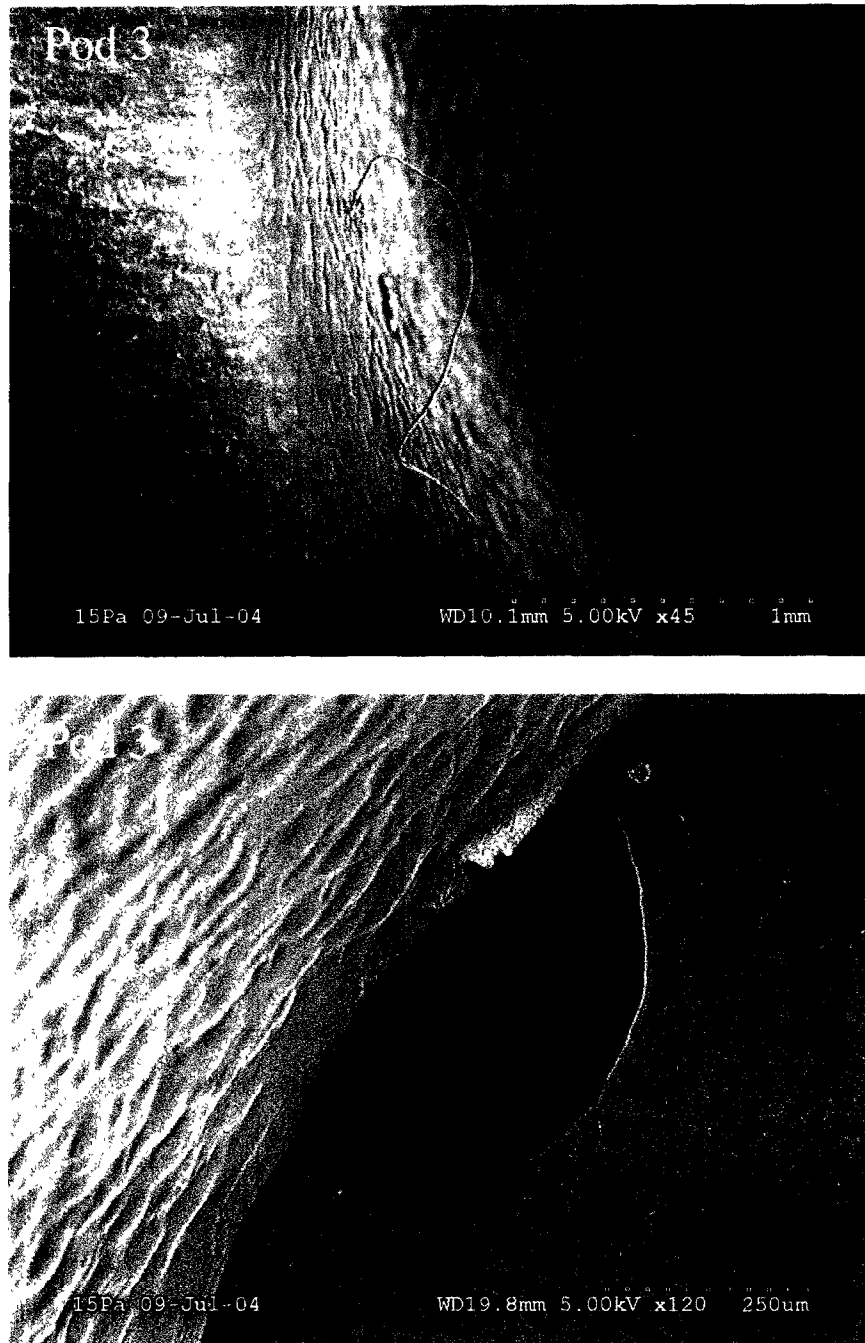
Figure 63. Images collected from Hitachi S3500N variable pressure scanning electron microscope in the areas of pod 3 on the **reprocessed Octopus 4[®] MT-104-13**. The images show hair on the pod surface and partially blocked hypotube opening. The number in the upper left indicates the pod # (see Figure 5). Scale bar in each image.

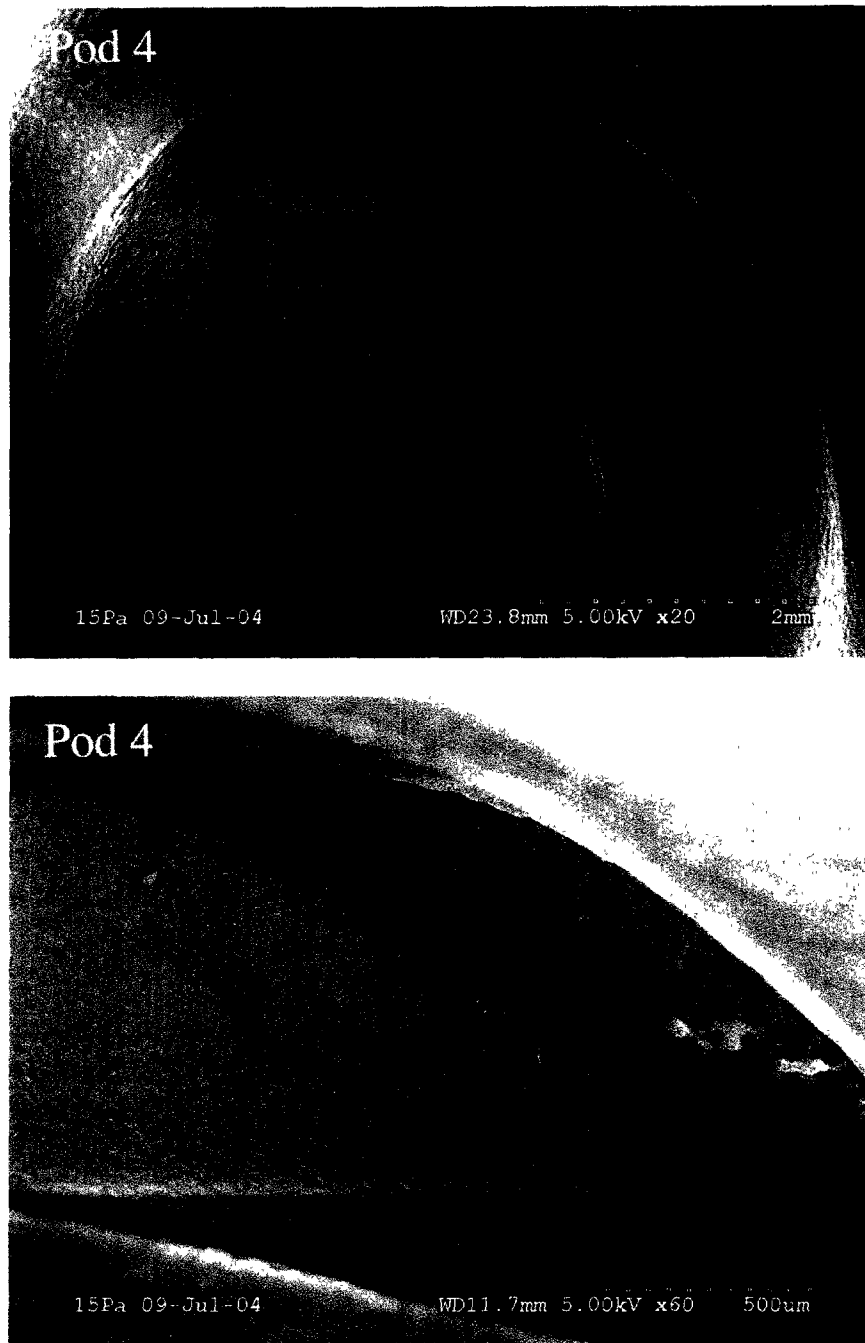
Figure 64. Images collected from Hitachi S3500N variable pressure scanning electron microscope in the areas of pod 4 on the **reprocessed Octopus 4[®] MT-104-13**. The images show contamination on surface of the hypotubing. The hypotube opening is completely blocked. Note sheet of bioburden and gap between hypotube and pod. The number in the upper left indicates the pod # (see Figure 5). Scale bar in each image.

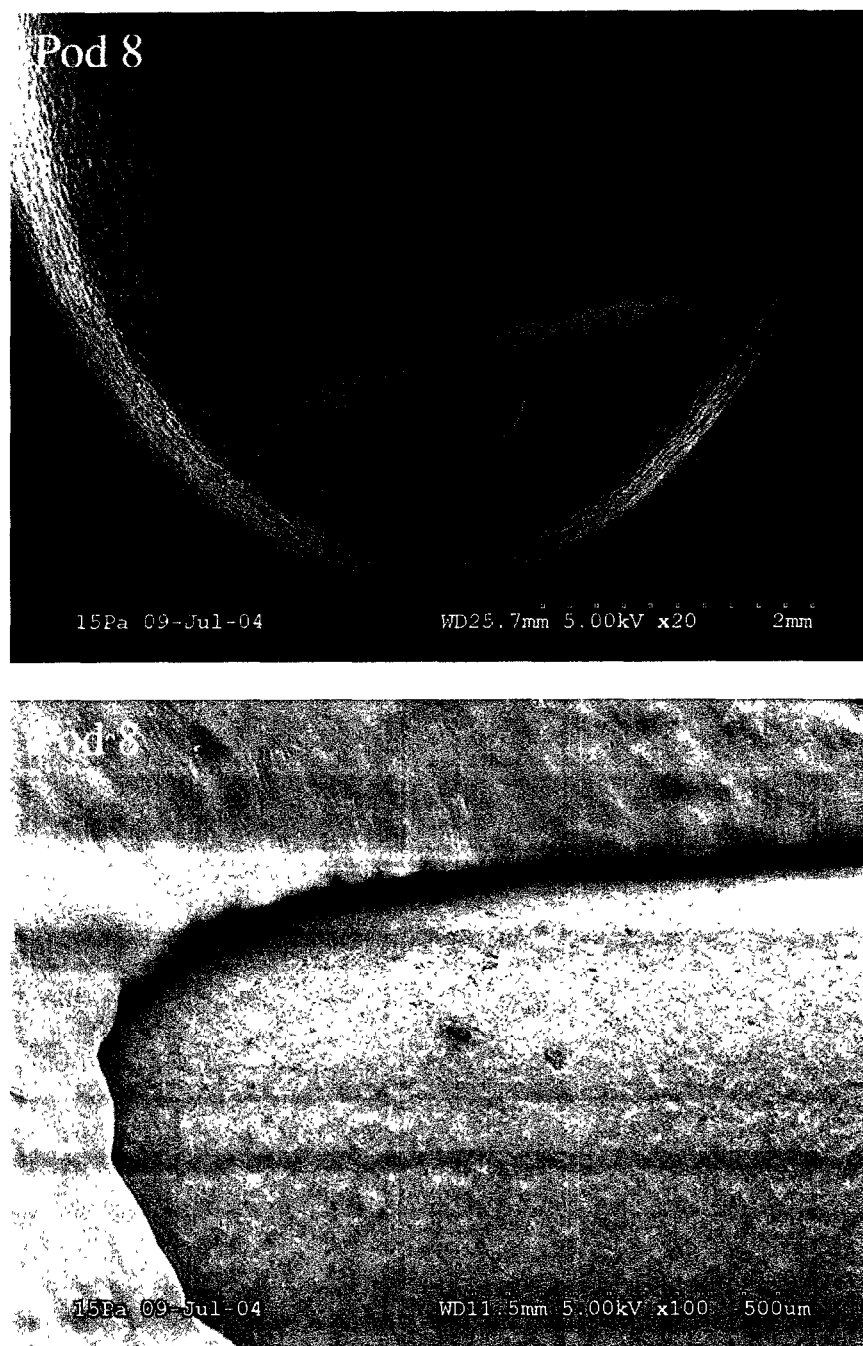
Figure 65. Images collected from Hitachi S3500N variable pressure scanning electron microscope in the areas of pod 8 on the **reprocessed Octopus 4[®] MT-104-13**. The images show little to no contamination on surface of the hypotubing. Note gap between hypotube and pod. The number in the upper left indicates the pod # (see Figure 5). Scale bar in each image.

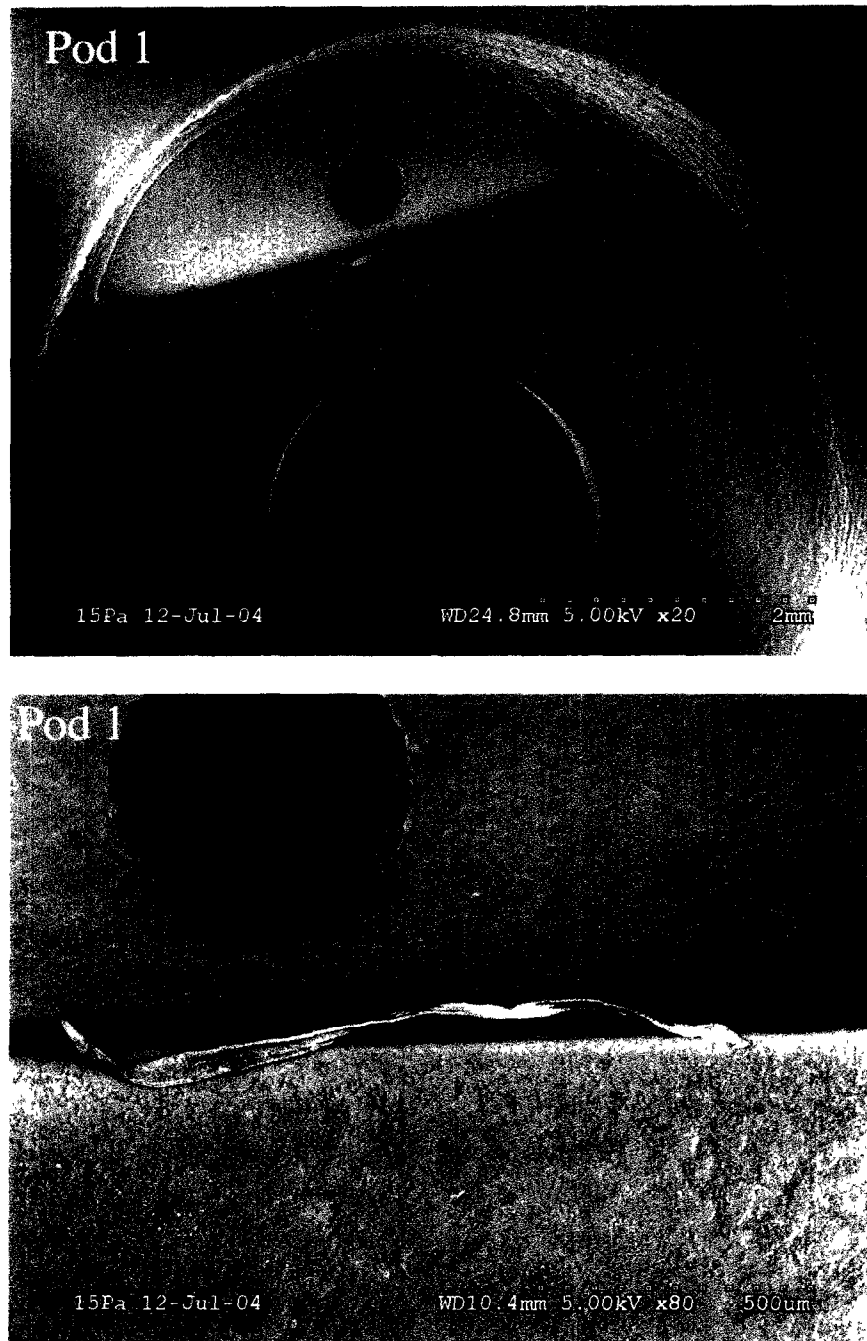
Figure 66. Images collected from Hitachi S3500N variable pressure scanning electron microscope in the areas of pod 1 on the **reprocessed Octopus 4[®] MT-104-16**. The images show gap between hypotube and pod. Note fiber in gap region. The number in the upper left indicates the pod # (see Figure 5). Scale bar in each image.

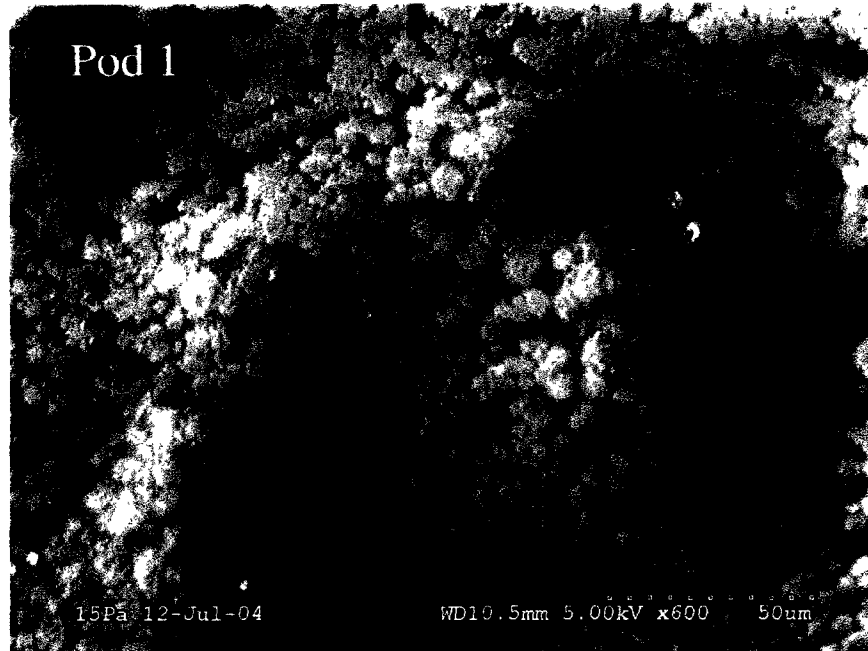
Figure 67. Image collected from Hitachi S3500N variable pressure scanning electron microscope in the area of pod 1 on the **reprocessed Octopus 4[®] MT-104-16**. The images show foreign crystalline substance in pod base. The number in the upper left indicates the pod # (see Figure 5). Scale bar in each image.

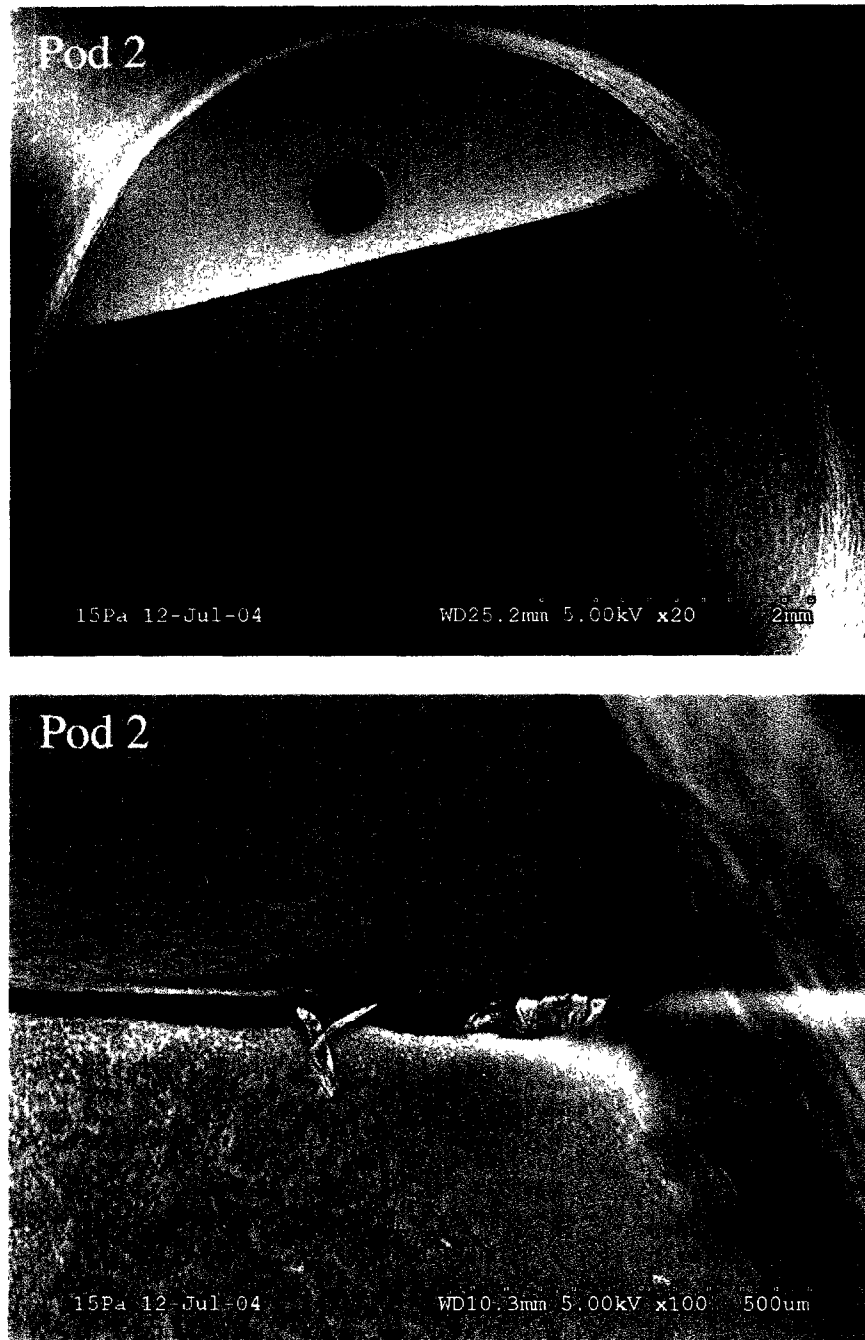
Figure 68. Images collected from Hitachi S3500N variable pressure scanning electron microscope in the areas of pod 2 on the **reprocessed Octopus 4[®] MT-104-16**. The images show gap between hypotube and pod. Note fiber and debris in gap region. The number in the upper left indicates the pod # (see Figure 5). Scale bar in each image.

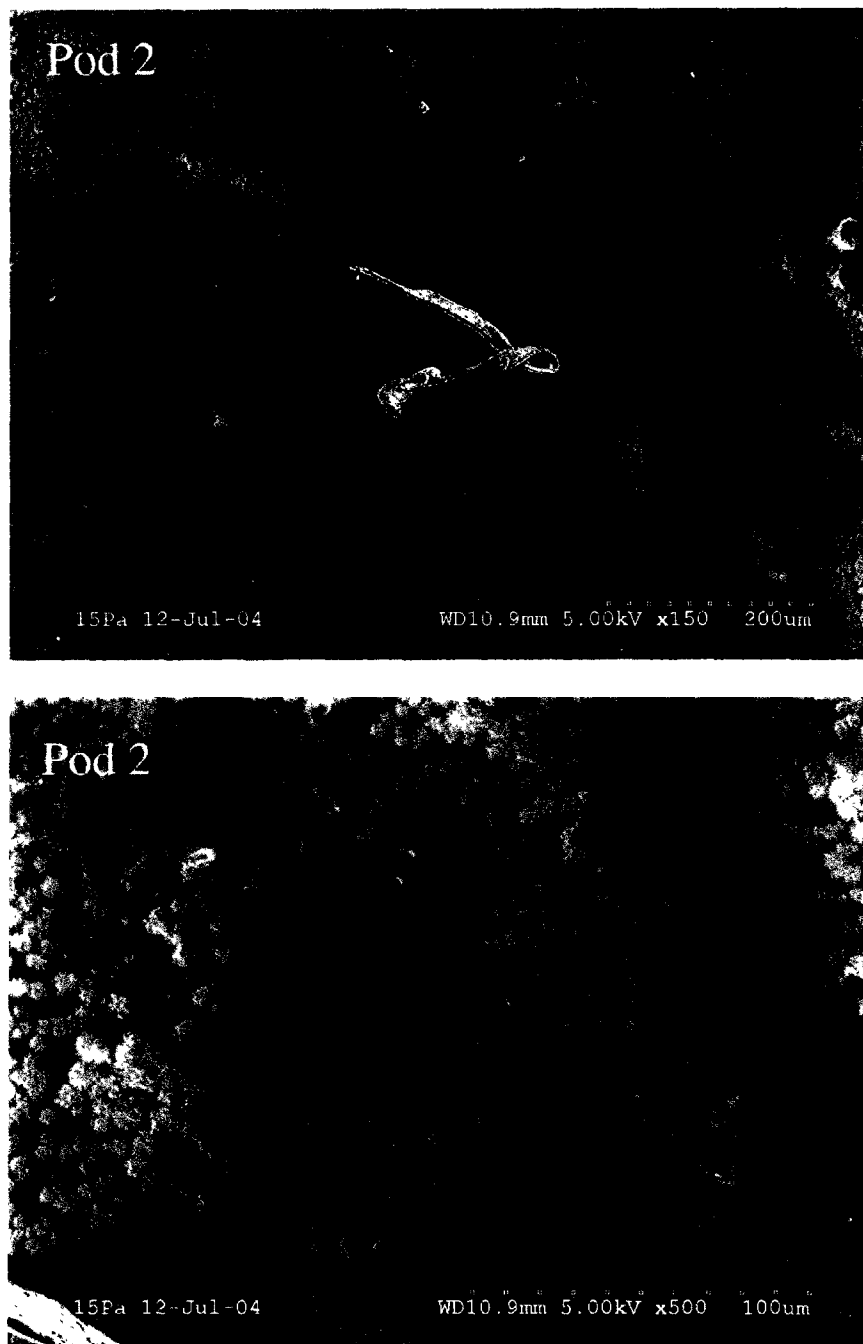
Figure 69. Images collected from Hitachi S3500N variable pressure scanning electron microscope in the area of pod 2 on the **reprocessed Octopus 4[®] MT-104-16**. The images show bioburden and fiber on pod base. The number in the upper left indicates the pod # (see Figure 5). Scale bar in each image.

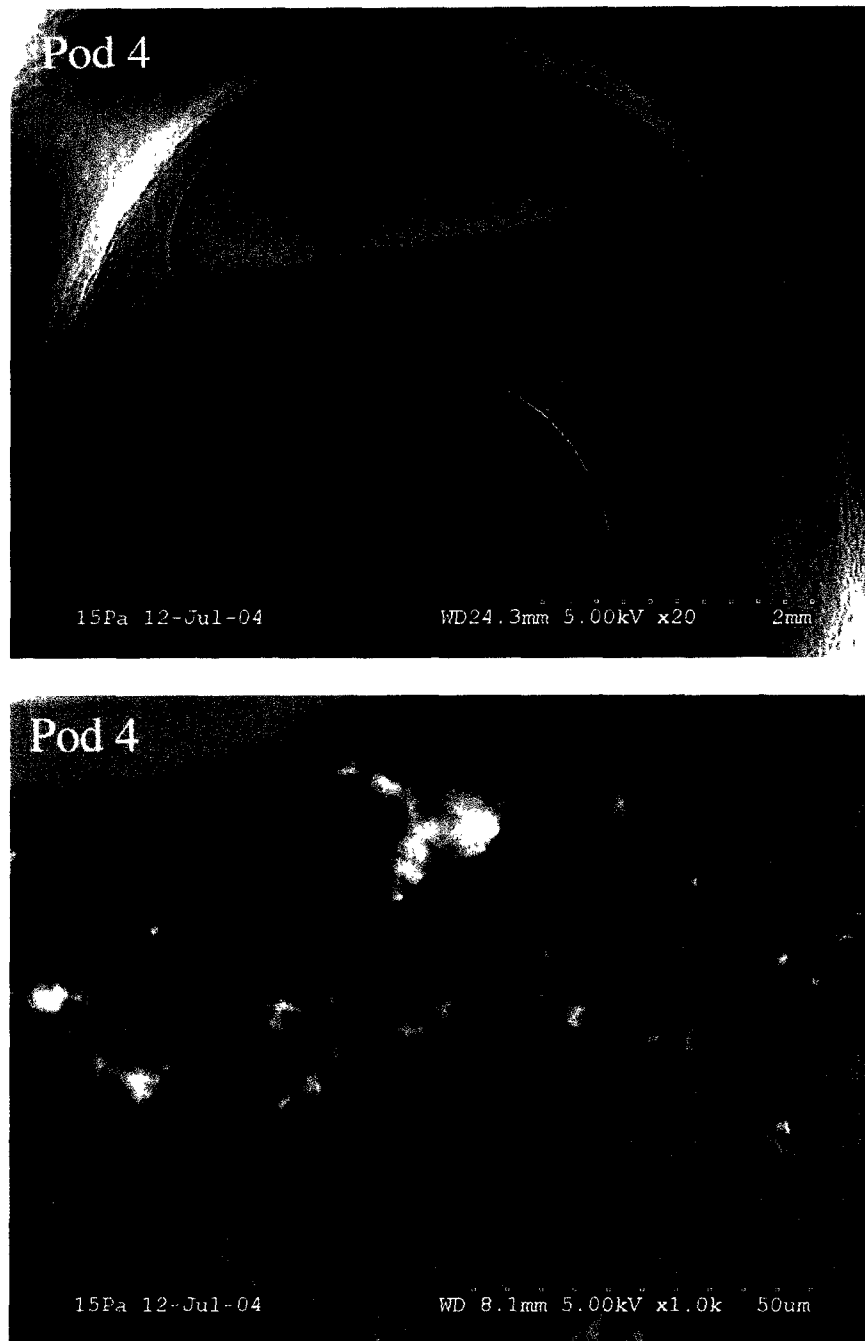
Figure 70. Image collected from Hitachi S3500N variable pressure scanning electron microscope in the area of pod 4 on the **reprocessed Octopus 4[®] MT-104-16**. The images show on hypotube near upper region of tube. The number in the upper left indicates the pod # (see Figure 5). Scale bar in each image.

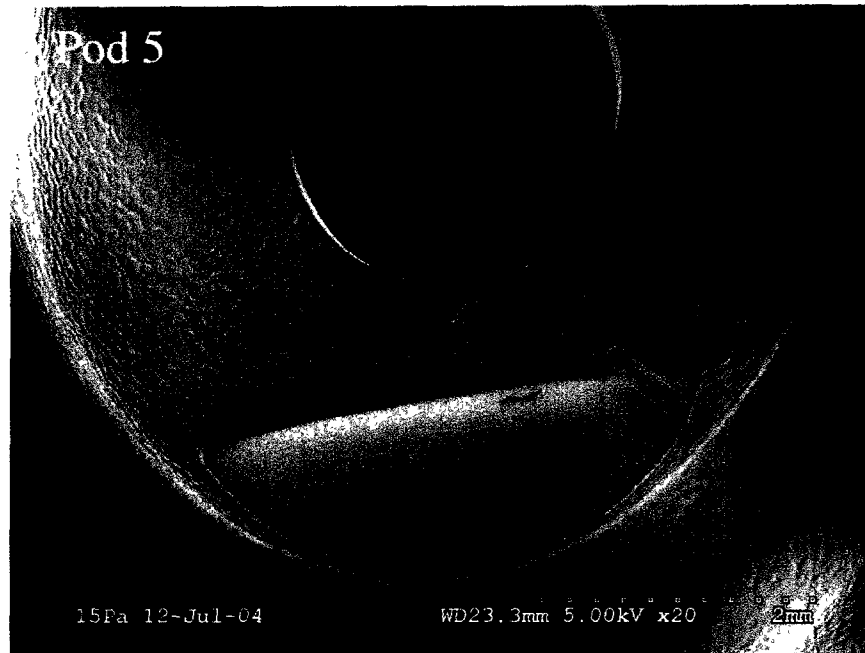
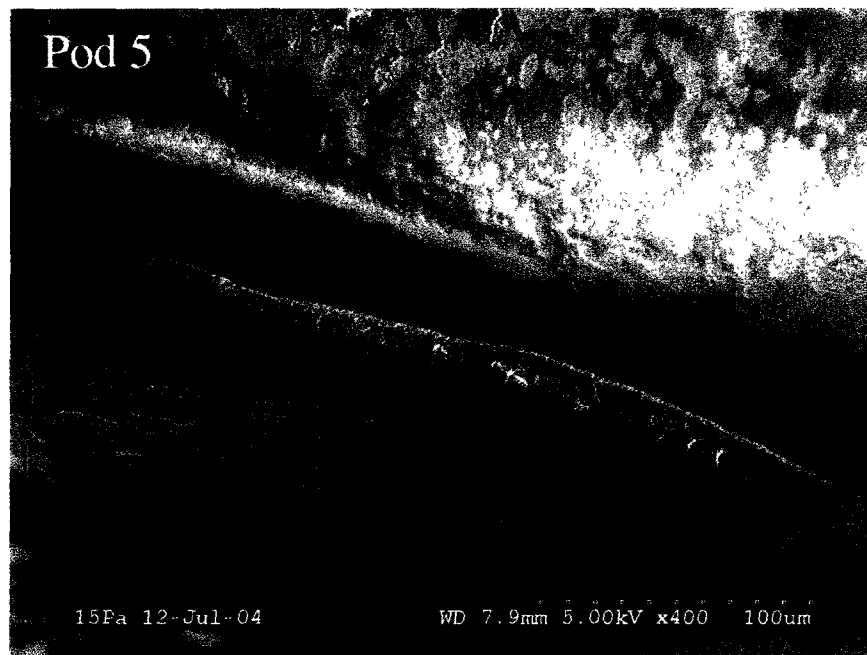
Figure 71. Images collected from Hitachi S3500N variable pressure scanning electron microscope in the areas of pod 5 on the **reprocessed Octopus 4[®] MT-104-16**. The images show gap between hypotube and pod. Note debris in gap region. The number in the upper left indicates the pod # (see Figure 5). Scale bar in each image.

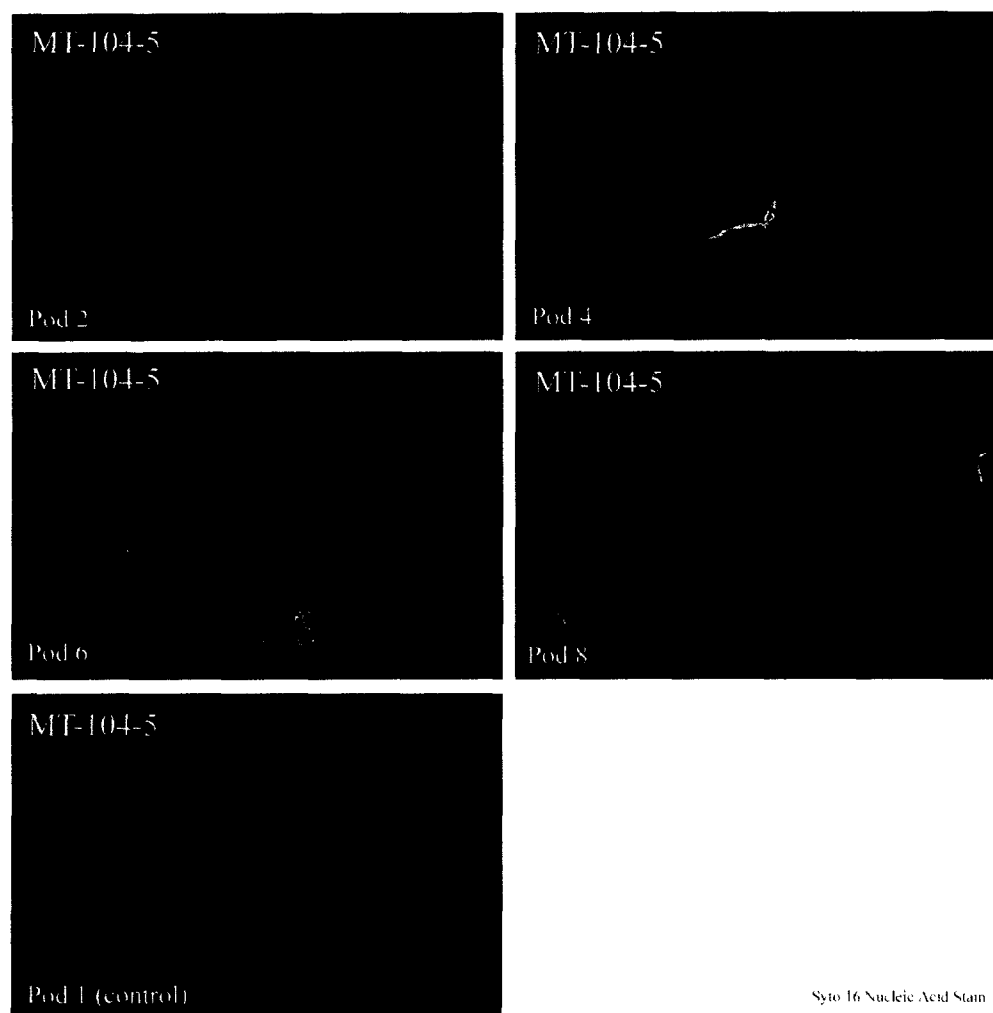
Figure 82. MT-104-5, pod #s 2, 4, 6 and 8 treated with Syto 16 nucleic acid probe. Projections (maximum intensity method) of series of optical sections collected from the laser scanning confocal microscope through the hypotube area of the pod following treatment with 1 μ M of the stain Syto 16. Bright regions indicate positive nucleic acid staining. Pod #1 is an unstained control image through the same area of the hypotube as the other images. The control image shows a low level of autofluorescence.
